### Steering Knuckle Dust Seal and Bearing Replacement (Four-Wheel Drive)

### CONTROL ARMS

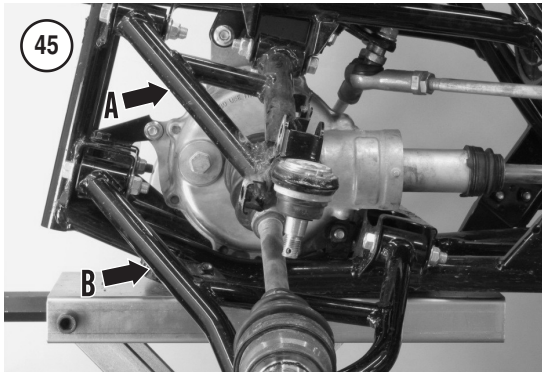
2. Remove the upper control arm as follows:
  - a. Remove the locknut and bolt (A, **Figure 44**) securing the shock absorber to the upper control arm.
  - b. Remove the brake hose and breather tube clamp bolt (B, **Figure 44**) from the upper control arm.
  - c. Remove locknuts and bolts and the upper control arm (A, **Figure 45**).
3. Remove the locknuts and bolts and the lower control arm (B, **Figure 45**).
4. Discard all of the control arm and lower shock absorber locknuts removed in Step 2 and Step 3.
5. Inspect the upper and lower control arms as described in this section.

6. Install the lower control arm (B, **Figure 45**) onto the frame and secure it with bolts and new locknuts.
7. Install the upper control arm (A, **Figure 45**) and secure it with bolts and new locknuts.
8. Install the shock absorber lower mounting bolt and a new locknut (A, **Figure 44**). Tighten the locknut to 30 N•m (22 ft.-lb.).
9. Install the brake hose and breather tube clamp bolt (B, **Figure 44**).
10. Install the steering knuckle as described in this chapter.
11. Install the front wheels as described in this chapter.
12. Lower the ATV so all four wheels are on the ground.
13. Tighten the upper control arm locknuts to 44 N•m (33 ft.-lb.).
14. Tighten the lower control arm locknuts to 44 N•m (33 ft.-lb.).

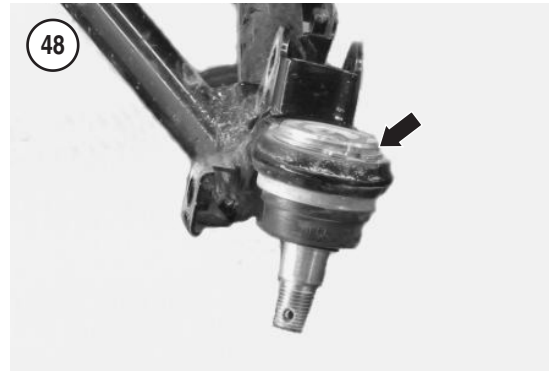
When cleaning the upper control arm, do not wash the ball joint in solvent. The ball joint cover (**Figure 46**) may be damaged or the grease contaminated.

1. Clean and dry the control arms.
2. Examine both control arms for bending, cracks or other damage. Replace them if necessary.
3. Inspect the upper control arm ball joint and rubber boot (**Figure 46**). Pivot the ball joint by hand. It should move freely. The ball joint is permanently packed with grease. If the rubber boot is damaged, dirt and moisture can enter the ball joint and destroy it. If the ball joint or boot is damaged, replace the ball joint as described in this chapter.
4. Inspect the pivot bolts and replace them if they are excessively worn or damaged.
5. Inspect the pivot bushings (**Figure 47**) for excessive wear, separation or other damage. If they are damaged, replace the control arm as the bushings cannot be replaced separately.

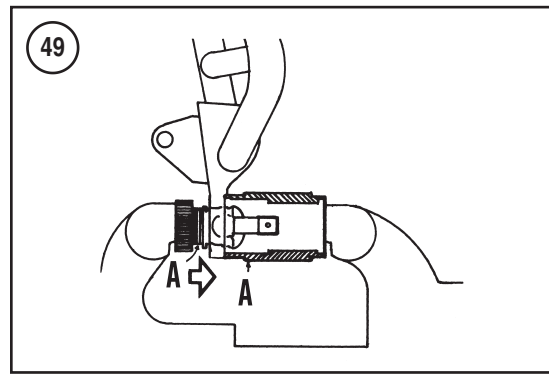
1. Remove the upper control arm as described in this chapter.
2. Remove the snap ring (**Figure 48**) securing the upper ball joint to the upper control arm.
3. Position the special tools (Honda part No. 07WMF-HN00100) or equivalents, with the A mark facing the ball joint and install the special tools and the control arm in a vise (**Figure 49**) or press.
4. Slowly press the ball joint out of the control arm.
5. Remove the special tools, control arm and ball joint from the vise.
6. Clean the ball joint receptacle in the control arm with solvent and thoroughly dry it.
7. Correctly position the new ball joint into the control arm and use the same special tools used for removal. Position the special tools with the B mark facing toward the ball joint.
8. Install the special tools and the control arm in a vise (**Figure 50**) or press.
